# Repair of an Unseated ididit Steering Column

For Part Number's 2620100010

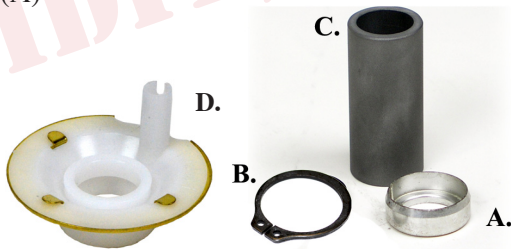
## Kit includes:

- 1- Race Retainer (A)
- 1- Snap Ring (B)
- 1- Push Tube (C)
- 1- Horn Cam (D)

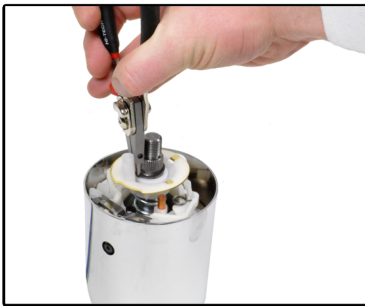
Figure 2

2. Use the snap ring pliers to remove the snap ring from its groove. If it is the old style wire ring, find the split and lift one end then walk the screwdriver around the shaft and the ring will come off. (Figure 2)

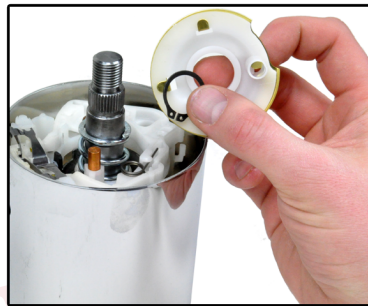
Figure 3

3. With the tension released you can remove the horn cam and load spring. Use the screwdriver to remove the bearing race retainer. (Figure 3)
4. There are two types of race retainers: Version one was tin and loosely looks like a bottle cap (Figure 4 A). The second version is a billet aluminum item. We will be using the billet aluminum one. (Figure 4 B)

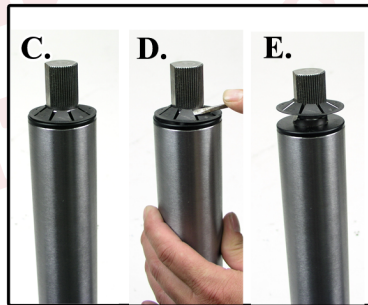
Figure 5

We are constantly looking for improvements to our products and there is one more that you should know about. Please look at the bottom of your column. There could be a push nut on the bottom of your column. If your column is equipped with this item it must be moved down the shaft away from the bushing at the bottom of the column. This push nut will prevent the shaft of the column from rising into contact with the bearings at the top of the column. The easiest way to do this is to spin the nut down. You could also work each of the fingers with the screwdriver or a strong knife blade. Normally, if you walk the nut down until it is sitting against the u-joint or rag joint, this will be enough. It is not necessary to remove the joint. When finished with this repair you can push this nut back up till it loosely touches the bushing. (Figure 5 C, D & E)

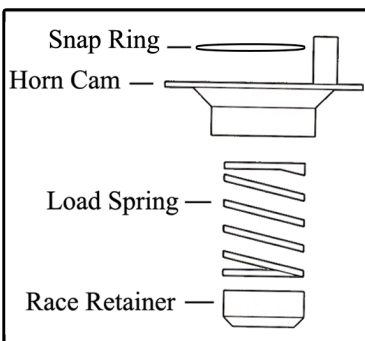
Figure 6

Order of Parts Diagram

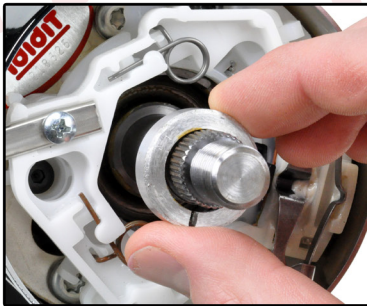
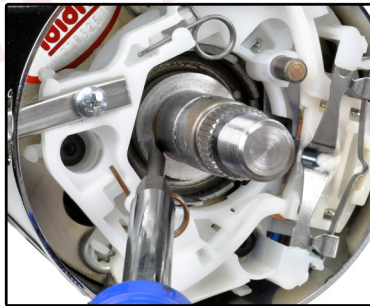
2. Now install the billet race retainer with the flat side facing up. Slide the retainer over the shaft, the bottom of the retainer seats in the race and acts as a wedge to remove any side movement. (Figure 7 & 8)

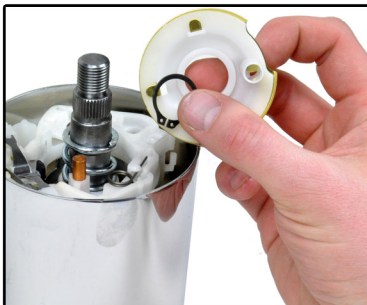
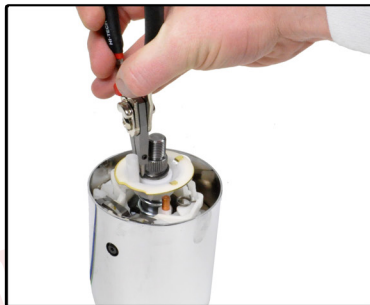
3. Now reinstall the load spring, the new horn cam and new snap ring. You might need to use the snap ring pliers to spread the snap ring over the shaft. (Figure 9 & 10)

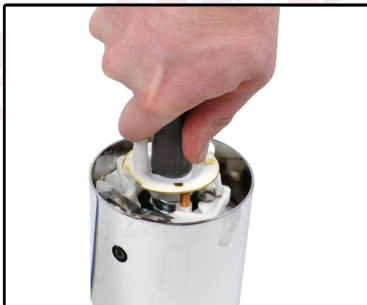
Figure 11

4. Now use the tube provided in the kit to compress the load spring and the clip down onto the shaft. This will require about 65 lbs of force. When the clip is in place you will hear it snap. This will set the preload on the bearings. (Figure 11)

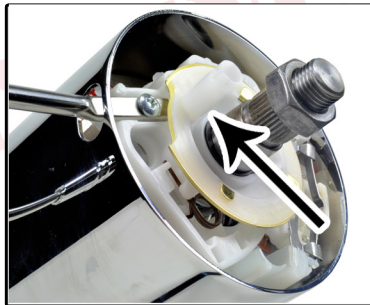
Figure 12

5. Now that the column is back together, we need to check and make sure your driving wheels are straight. Once they are, gently turn the white tube to the 10:30 position. This will center the timing for the turn signal cancellation. (Figure 12) Then install the steering wheel and horn wire.
